Fiber-Optic Strain Monitoring on a Navy Cruiser

J.M. Nichols,¹ M. Seaver,¹ S.T. Trickey,¹
K. Scandell,² and L.W. Salvino³

Introduction: A number of CG class vessels in the U.S. Navy are experiencing cracking at various locations on the aluminum superstructure. The cracking has been observed on the 04 level deckplate, the overhead of one of the AN/SPG-62 Illuminator (radar) rooms, the intake bulkhead, and several other locations on one particular class of vessel.^{1,2} The cracking is, in many cases, persistent, recurrent (even after repairs), and has the potential to influence mission critical operations aboard ships.

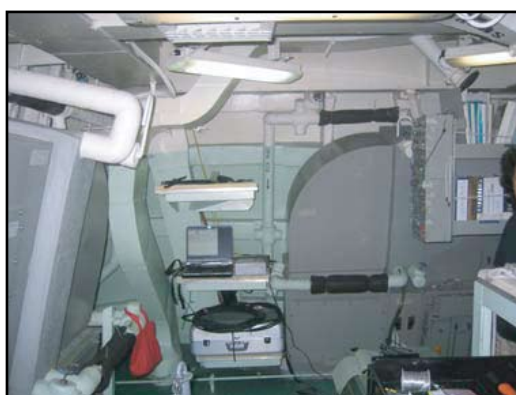
(a) The computer and demodulation hardware are located on the middle shelf in the back corner of the radar room. (b) The overhead directly above the shelves is where the gratings were located. The four FBG rosettes (A, B, C, and D) are shown with most of the insulation replaced.

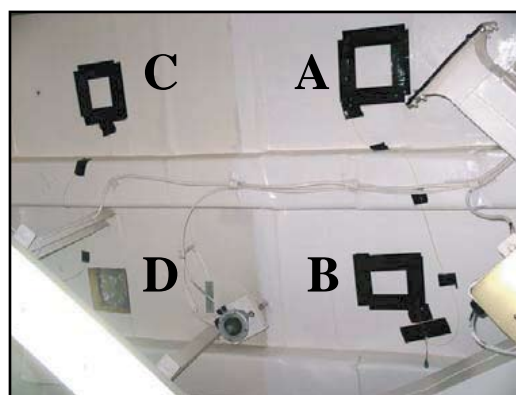
(b)

The sensing system was installed during a single day on May 15, 2007. Four fiber Bragg grating (FBG) rosettes (referred to as A, B, C, and D in this article) were installed in the overhead of #4 Radar (05-316-0-C) where the ship had previously experienced cracking. This space houses mission-critical equipment (both communications and weapons) and was therefore deemed an ideal candidate for monitoring. Additionally, this particular location allowed for the simplest, most unintrusive installation of all potential areas surveyed. The FBG strain rosettes, each consisting of three

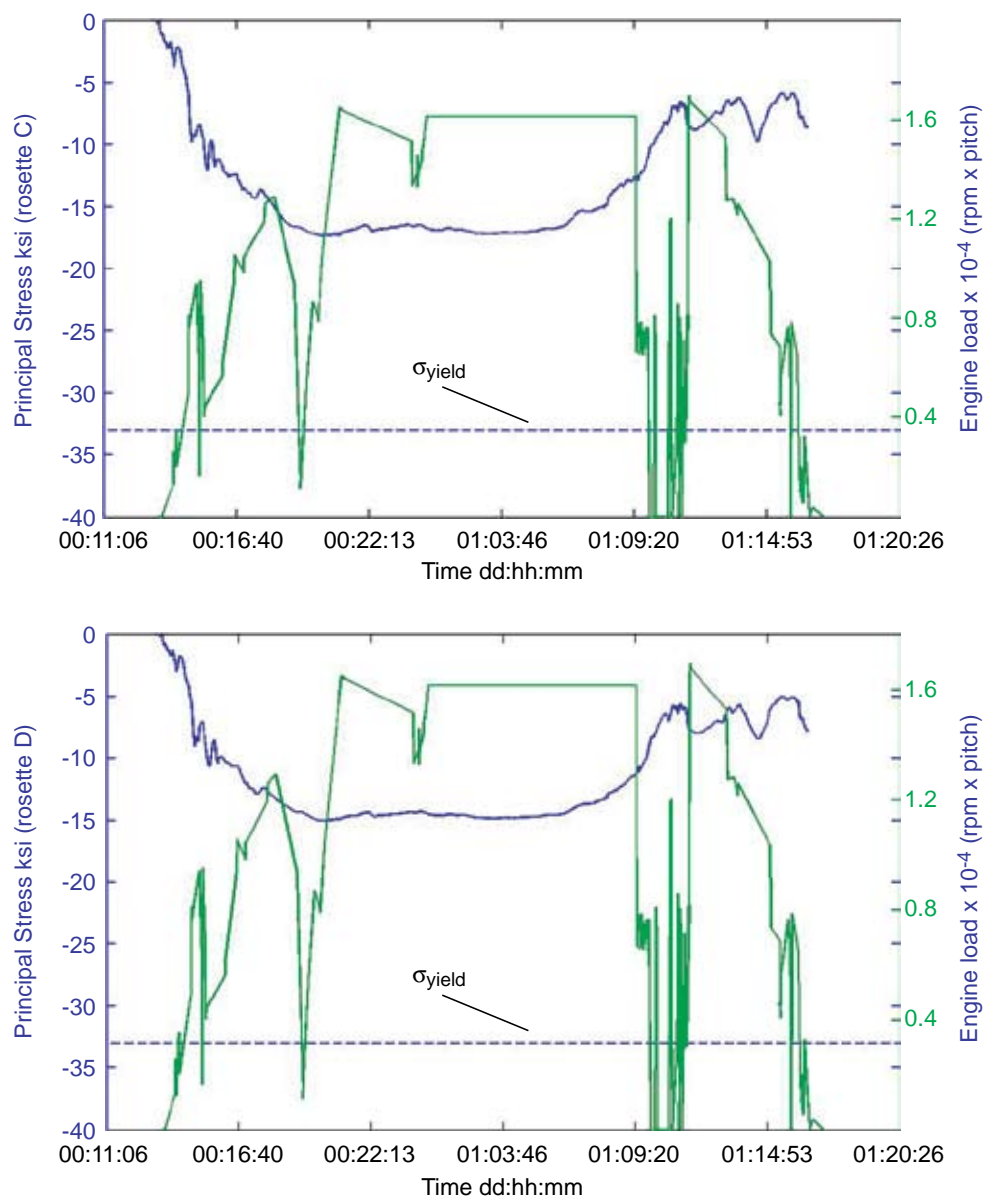
**FIGURE 8**

Deck Plate Response to Ship Maneuvers: Figure 8 shows plots of the principal stresses vs time for rosettes C and D (see again Fig. 7 for rosette placement). In this figure, note that the measured stresses are all compressive, with the largest magnitudes beginning about 2000 hours and ending near 0600 the next morning. Also plotted is a measure of engine load (shaft rpm \times pitch). The data shows a strong correlation between engine load and deckplate compressive stress. As the ship picks up speed, the stress observed in the deckplate tends to increase. This may be due to thermal loading from the engine transferring to and stabilizing in the ship structure or perhaps direct structural loading resulting from drag created by speed increases. Engine load appears to be one of the primary mechanisms causing excessive stress in the deckplate. Also plotted in Fig. 8 is the yield stress for the deckplate material, σ_{yield} . The observed strain variations are 50% yield of the base metal.

Conclusions and Recommendations: The data collection from this particular ship was largely successful and resulted in some preliminary results that are useful in understanding the cause of the recurring deck cracking. First of all, the primary source of strain on the deckplate cannot be attributed to ship maneuvers or slewing of the AN/SPG-62 Illuminator. Neither action resulted in more than $10 \mu\epsilon$ of load. Secondly, the primary strain does not appear to be the result of thermal affects. Rather there exists a large compressive load, correlated with engine speed, that forms in the deckplate as the ship gets under way.

Principal stresses recorded during the trip from rosettes C and D. Also shown is the yield stress for the deck material. Note that the largest stresses began near sunset on 6/7/07 and ended about sunrise on 6/8/07. Stress correlates well with engine load.

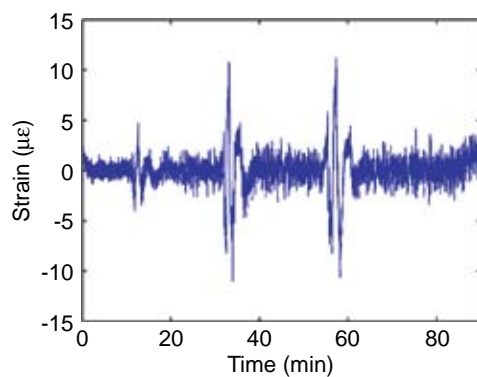
**FIGURE 9**

A series of turns was performed at varying speeds to determine the influence of ship maneuvers on the deck strains. Beginning at approximately 19:24, the ship's speed was reduced to 8 knots. The speed was then slowly increased to 20 knots over the course of the next 45 min. At 20:11, moving at 20 knots, the ship performed a sharp right turn ("hard rudder right"), followed by a hard left turn, followed by another hard right turn. The entire sequence lasted approximately 5 minutes. The ship's speed was then increased to 27 knots and the same sequence of turns was conducted. Finally, the ship's speed was set in excess of 27 knots and the sequence repeated once more. This final set of turns was completed at 21:00. Figure 9 displays the sequence of data recorded during maneuvers. The time axis shown in Fig. 9 is shown relative to the beginning of the maneuvers. Several observations can be made regarding the deckplate response to high speed turns. First and foremost, the maximum strains observed due

to the ship maneuvers were roughly $\pm 10 \mu\epsilon$. These values are extremely small and are not likely to be the cause of any significant structural damage. Although the magnitudes of the strain values do increase with speed, the ship will not likely see maximum knots for prolonged periods, thus hard turns at speed are not an issue in deckplate cracking.

Sensor data recorded from sensor 3 of rosette C showing the strain values recorded during a series of hard turns at high speed.
